**Flood Control Project Maintenance
Levee Inspections**

Fall 2011 Levee Maintenance Deficiency Summary Report

San Joaquin River Basin

Reclamation District No. 2062 Stewart

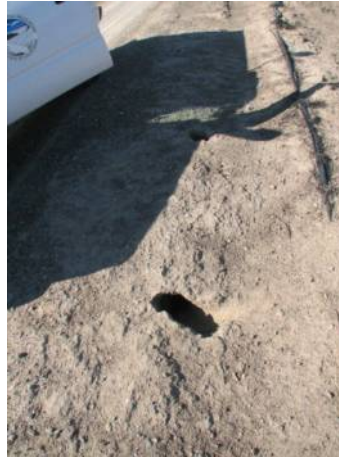
Levee Mile Report Line	10
Start Levee Mile	1.83
End Levee Mile	1.83
Location	Water Side
Category	Earthen Levee
Item	Animal Control
10/20/2011 Large burrow located near crown on waterside slope of levee.	
jeto_f_20111024_493.jpg

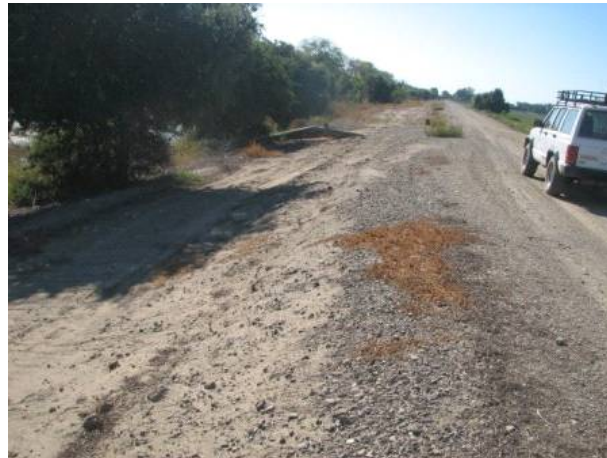
SJR2011_RD2062U02RM2.14_2.jpg

Upstream view of scarp.

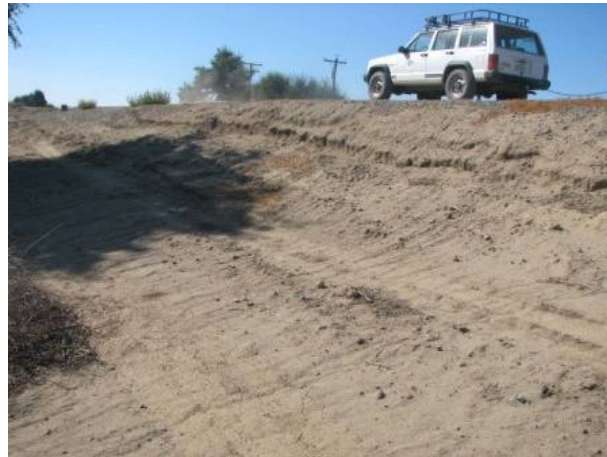
SJR2011_RD2062U02RM2.14_3.jpg

Upstream view of site.

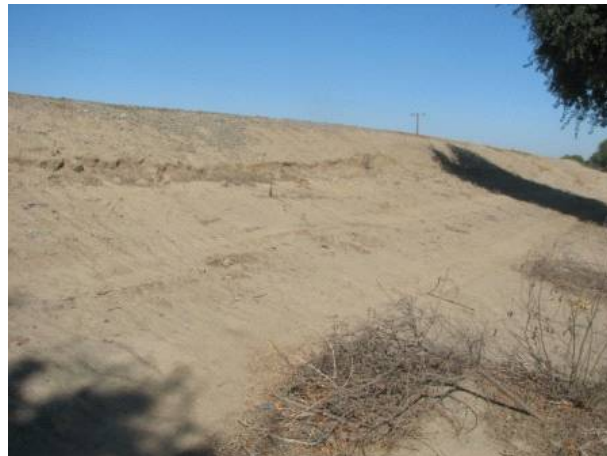
SJR2011_RD2062U02RM2.14_4.jpg

Downstream view of site.

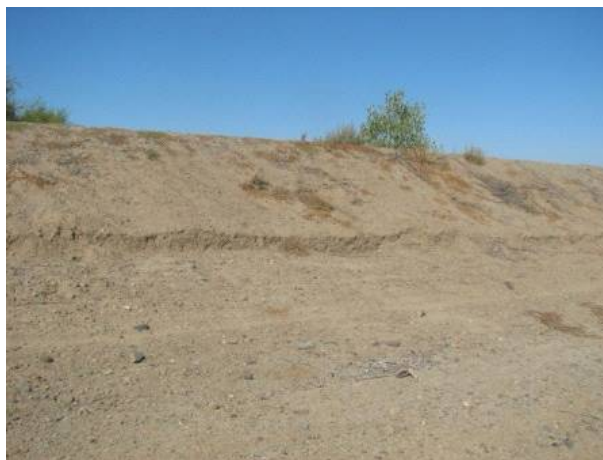
SJR2011_RD2062U02RM1.94_1.jpg

Downstream view of site. Note the vertical scarp at the toe.

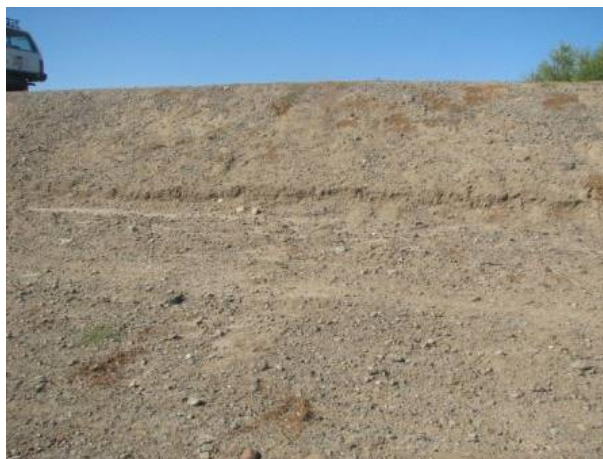
SJR2011_RD2062U02RM1.94_2.jpg

Direct view of site.

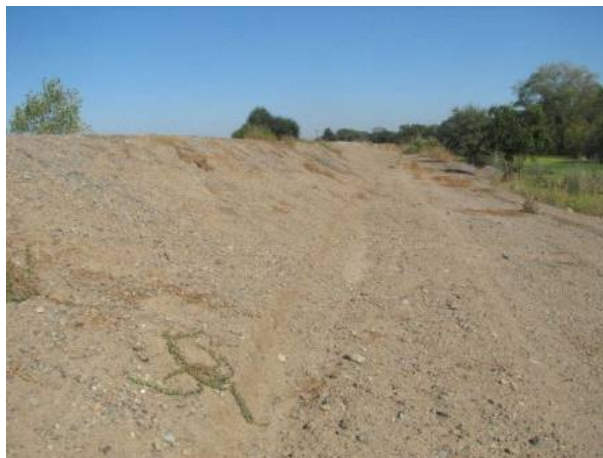
SJR2011_RD2062U02RM1.94_3.jpg

Upstream view of site.

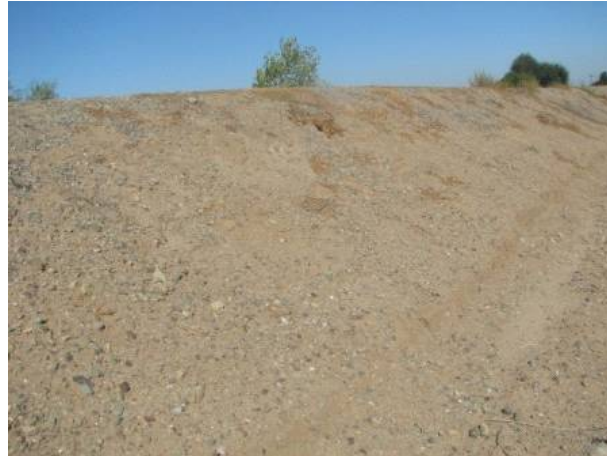
SJR2011_RD2062U02RM1.94_4.jpg

Upstream view of site.

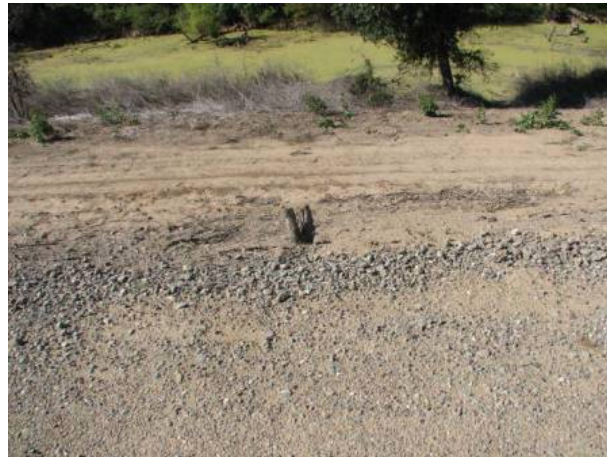
jeto_f_20110923_180.jpg

05/11/2011 Small stump in waterside slope.

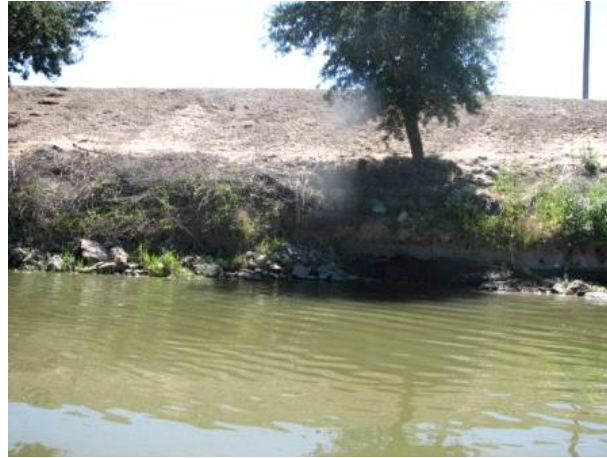
SJR2011_RD2062U03RM29.93_1.jpg

Front view of erosion at the most upstream of the site

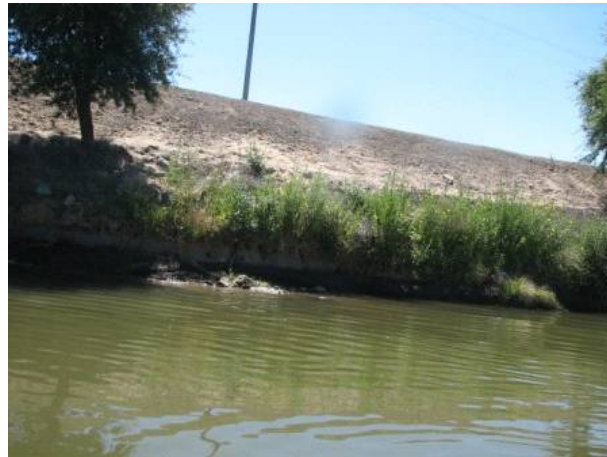
SJR2011_RD2062U03RM29.93_2.jpg

Front view of the erosion

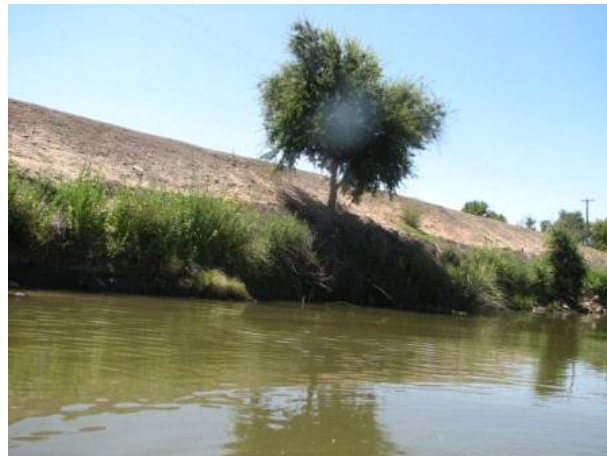
SJR2011_RD2062U03RM29.93_3.jpg

Upstream view of the erosion near the end of the site

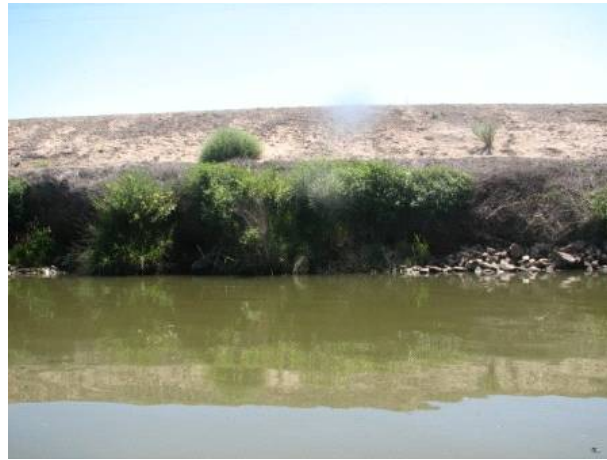
SJR2011_RD2062U03RM29.93_4.jpg

Front view of the erosion. Note the dense vegetation.

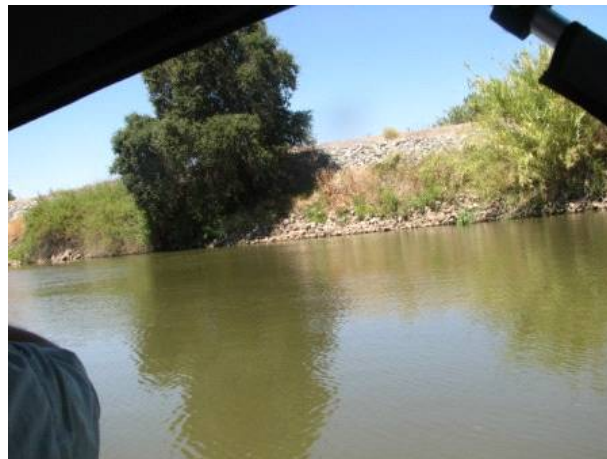
SJR2011_RD2062U03RM30.02_1.jpg

Downstream view of the site

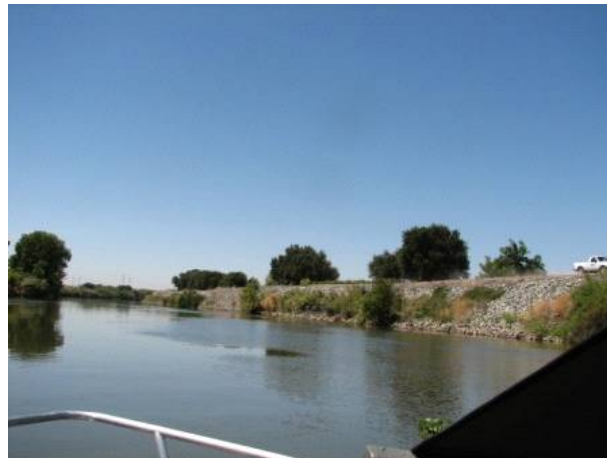
SJR2011_RD2062U03RM30.02_2.jpg

Downstream view of the site

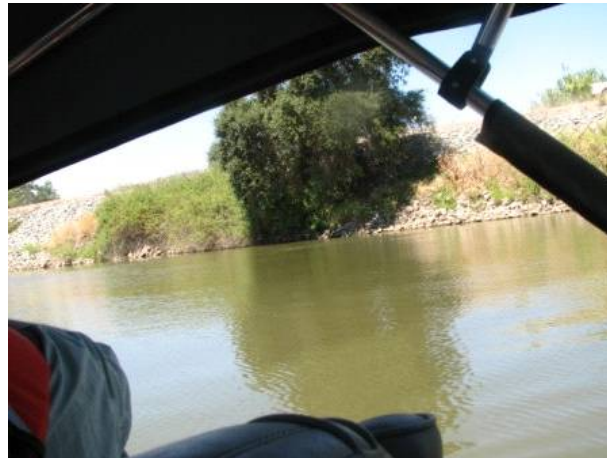
SJR2011_RD2062U03RM30.02_3.jpg

Front view of the site. Note the vegetation and trees on site

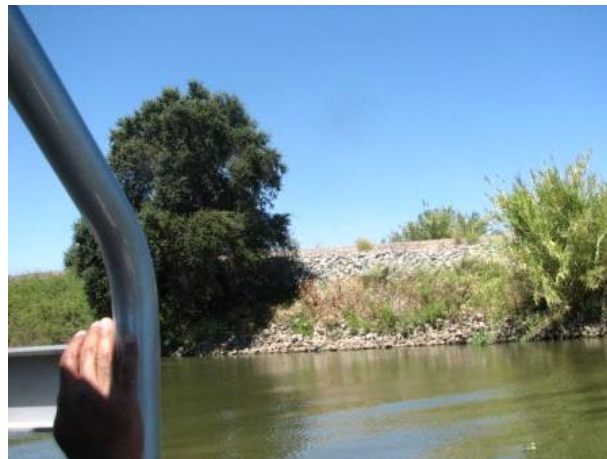
SJR2011_RD2062U03RM30.02_4.jpg

Front view of the site

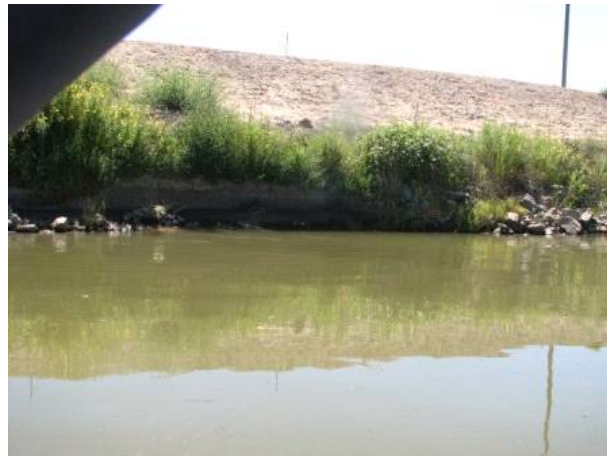
SJR2011_RD2062U03RM30.1_1.jpg

5	0.18	0.18	Supplemental	DWR Erosion Survey	WS	U	Inspector Comments: 08/23/2011: The protection at the levee toe has been washed away. [2011 Site ID:RD2062U03RM30.1]	37.810468 ° -121.387492 °	37.810468 ° -121.387492 °	4 Y
6	0.23	0.32	Supplemental	DWR Erosion Survey	WS	U	Inspector Comments: 08/23/2011: No significant changes observed on site. Dense vegetation visible along the water line. 09/07/2010: No significant changes observed on site. Much of the upper slope was recently cleared of vegetation by spraying. 4- to 6-foot vertical scarp and pocket erosions are lined along a span of 475 feet. In some sections, the vertical scarp encroaches into the levee prism. There is a lack of berm along this reach, exposing the levee slope to high flow velocities during normal and flood events. 08/06/2010: Recommended as local maintenance issue, per CLRO. 03/09/2010: As discussed with Michael Moncrief of MBK Engineers, the site will be 'addressed' later this year. 09/29/2009: No major change observed since last visit; pocket erosion and a vertical scarp forming; this site was combined with Site RM30.13 and 30.02 with a combined total erosion length of 475 feet; recommended as annual assessment and monitoring of site, per CLRO CES Evaluation 2008 Report; previously rated "M". 11/05/2008: Top of vertical scarp has rip rap that appears to be sliding; rodent holes; existing toe rip rap. [2011 Site ID:RD2062U03RM30.19]	37.810609 ° -121.385879 °	37.810609 ° -121.385879 °	5 Y

Direct view of the site. The erosion is vertical

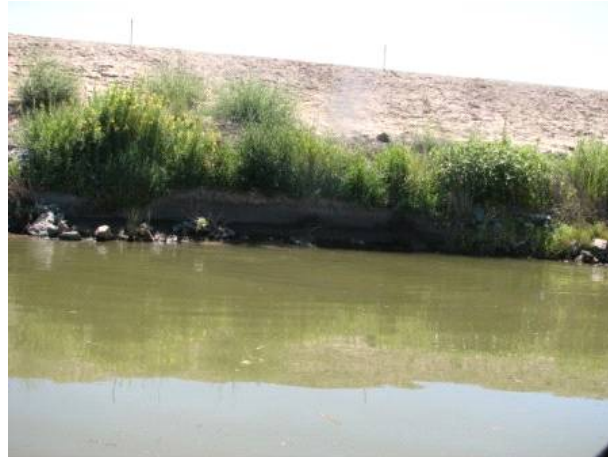
SJR2011_RD2062U03RM30.1_2.jpg

Front view of the erosion

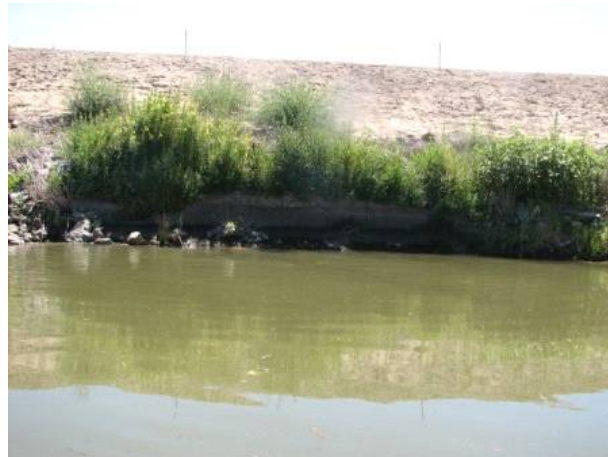
SJR2011_RD2062U03RM30.1_3.jpg

Front view of the erosion

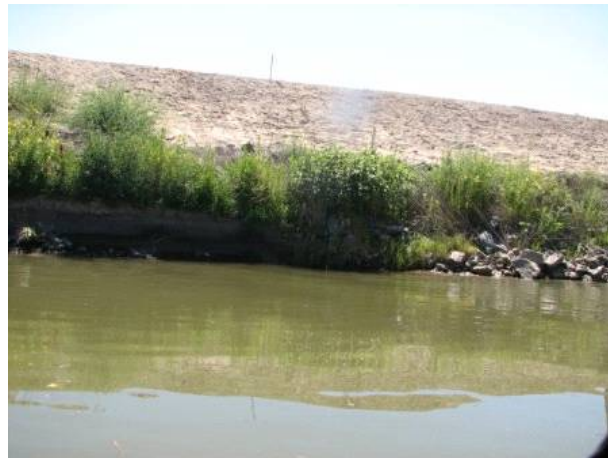
SJR2011_RD2062U03RM30.1_4.jpg

Front view of the site. Note the protection downstream of the erosion

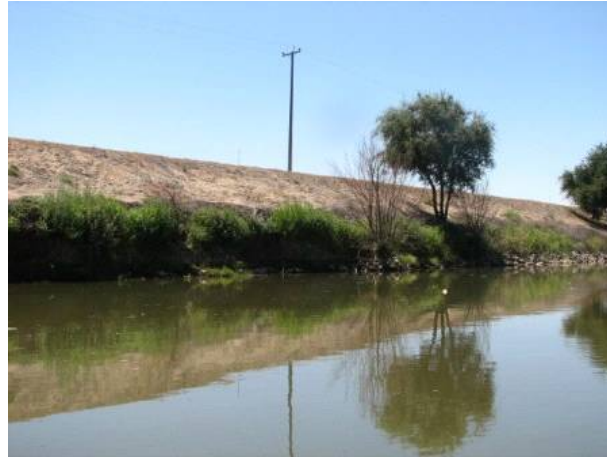
SJR2011_RD2062U03RM30.19_4.jpg

Front view of the site with dense vegetation

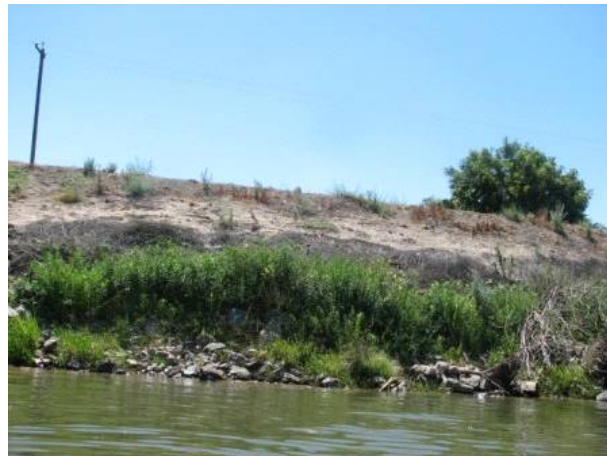
SJR2011_RD2062U03RM30.27_2.jpg

downstream view of the site

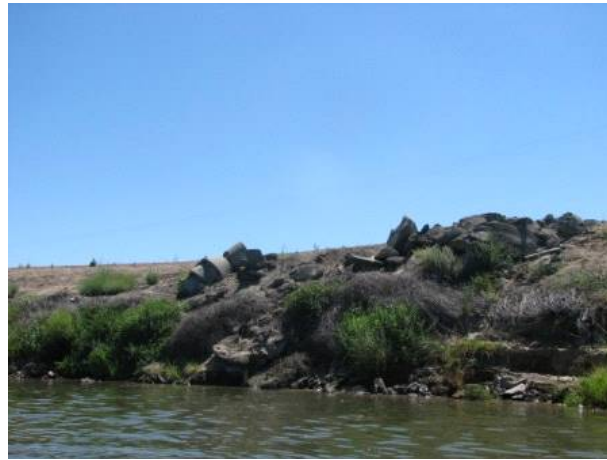
SJR2011_RD2062U03RM30.27_3.jpg

Front view of the erosion. Note the protection at the upstream of the site.

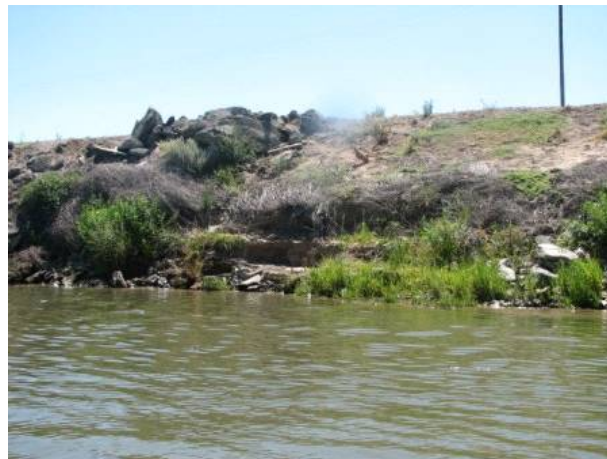
SJR2011_RD2062U03RM30.27_4.jpg

Front view of the site

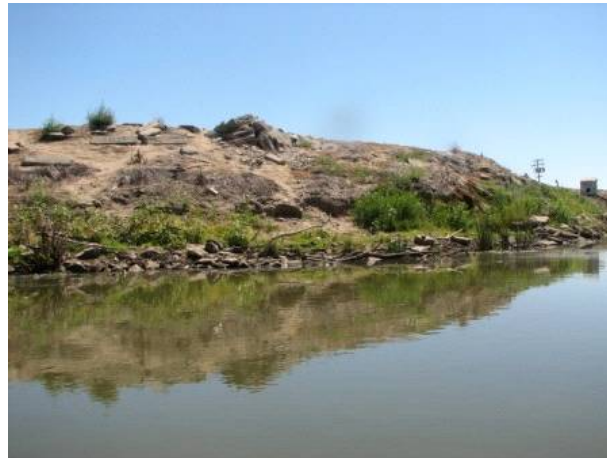
SJR2011_RD2062U03RM30.43_3.jpg

Front view of the site. Rip rap no longer adequately protecting levee slope.

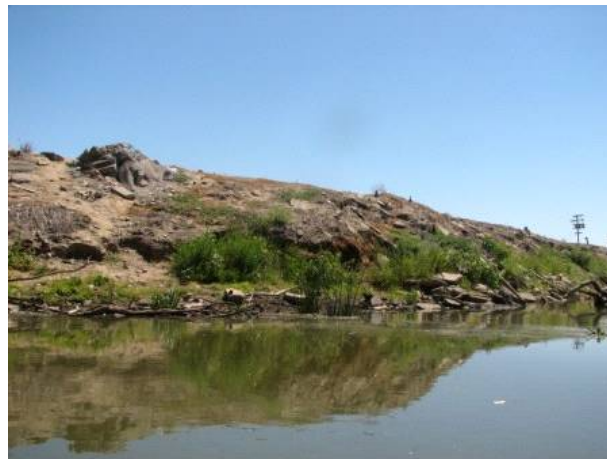
SJR2011_RD2062U03RM30.43_4.jpg

Downstream view of the site.

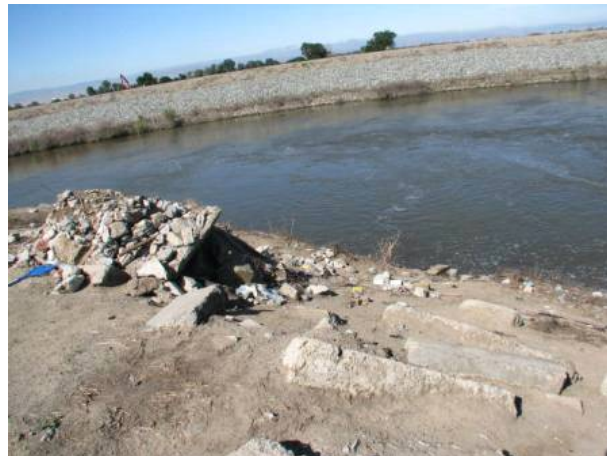
jeto_f_20110923_199.jpg

05/11/2011 Trash mixed in with concrete debris pile, needs to be removed.

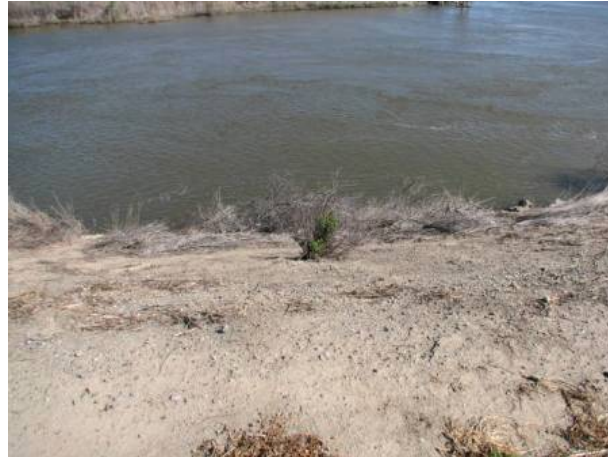
jeto_f_20110923_200.jpg

05/11/2011 Stump in slope, new growth in center of photo is at the location of the stump.

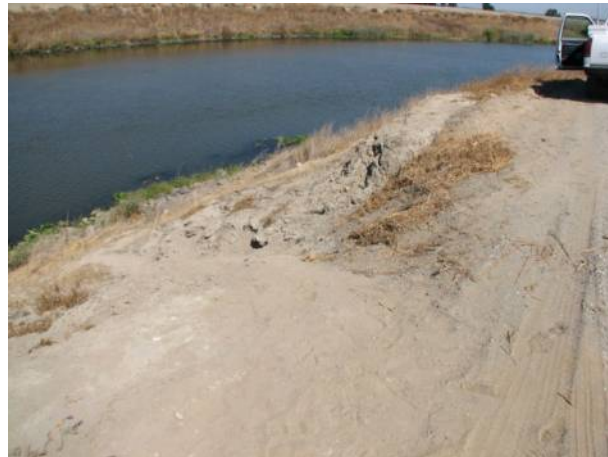
jeto_f_20110923_201.jpg

Slope erosion from crown surface runoff and foot traffic.

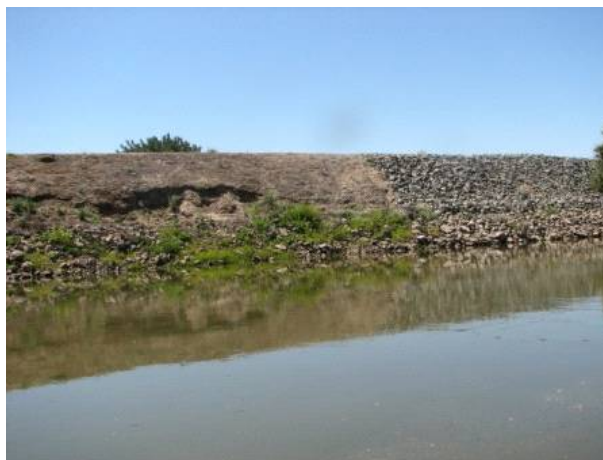
SJR2011_RD2062U03RM31.12_1.jpg

Front view of the site. Existing scalloped erosion is immediately downstream of rip rap section.

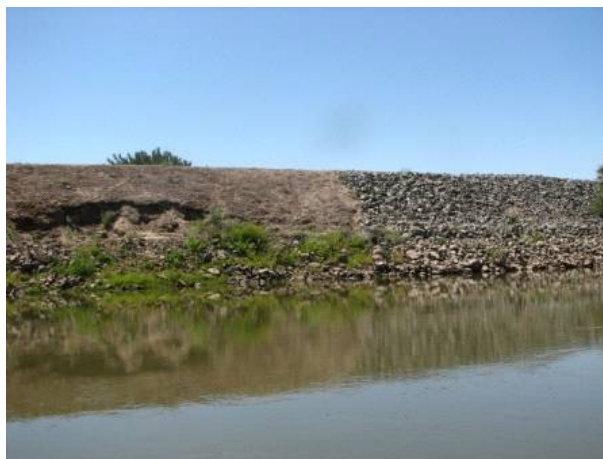
SJR2011_RD2062U03RM31.12_2.jpg

Upstream view of the site

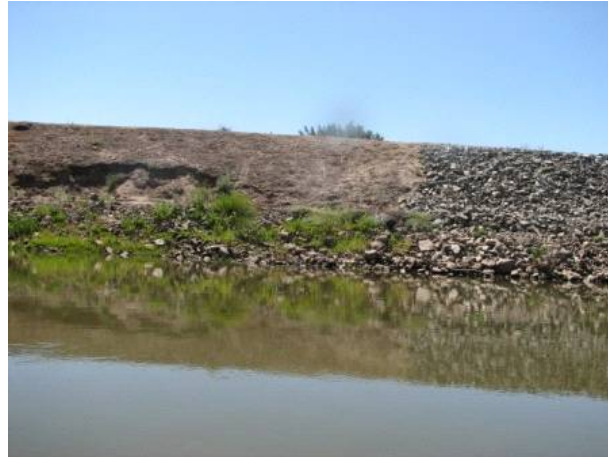
SJR2011_RD2062U03RM31.12_4.jpg

Front view of the site just above existing rip rap.

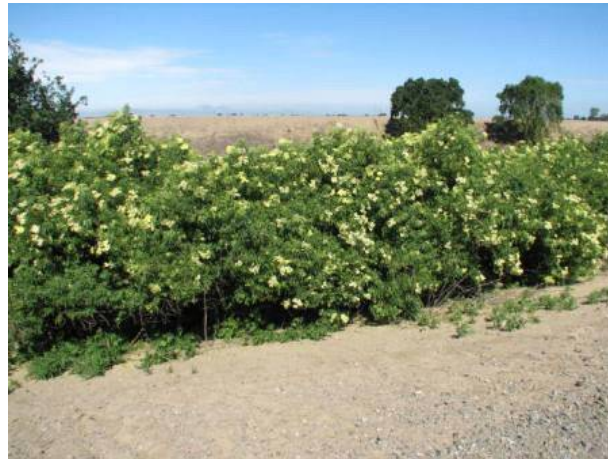
jeto_f_20110923_202.jpg

05/11/2011 Elderberry bush on water side slope.

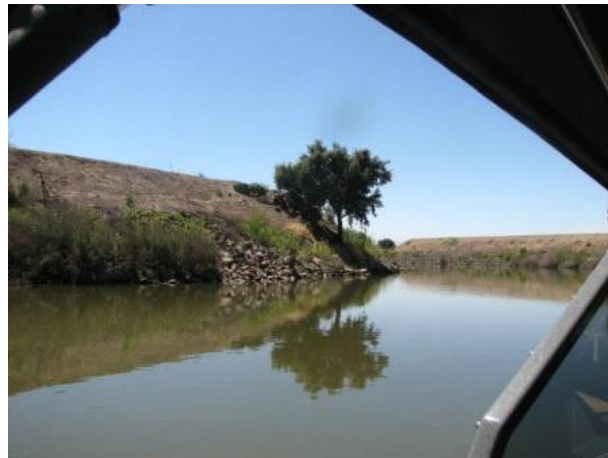
SJR2011_RD2062U03RM31.28_1.jpg

Upstream view of the site where a small to medium sized Oak tree is located.

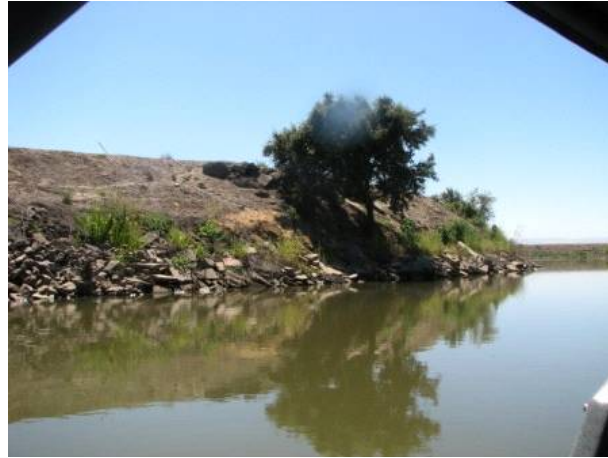
SJR2011_RD2062U03RM31.28_2.jpg

A closer look of the site

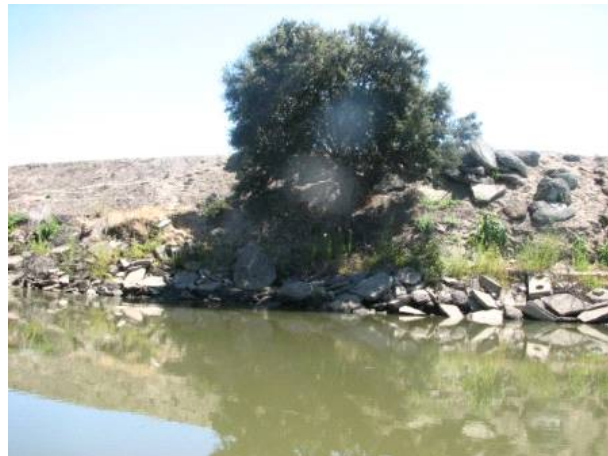
SJR2011_RD2062U03RM31.28_4.jpg

Downstream view of the site.

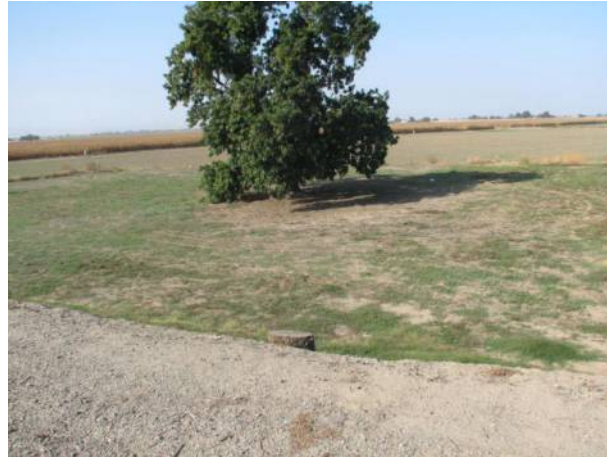
jeto_f_20111031_499.jpg

10/21/2011 Photo taken the next day. Stump can be seen in the lower center of the photo.

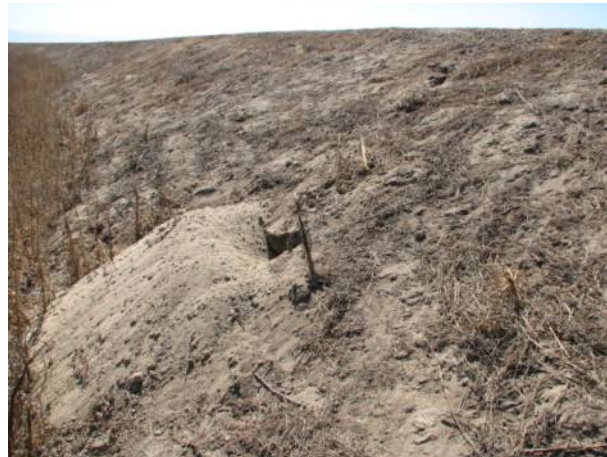
jeto_f_20110923_206.jpg

Animal burrow on levee slope.

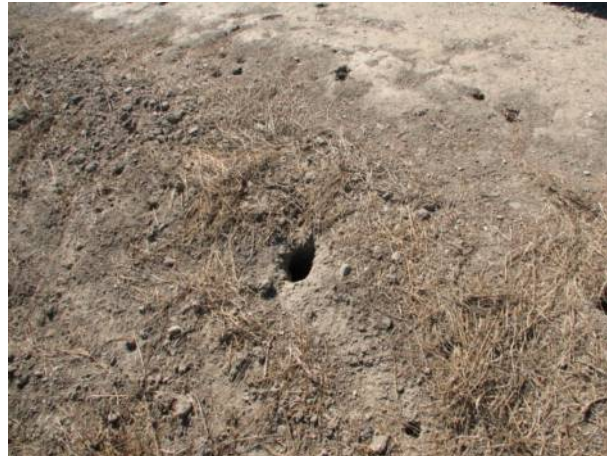
jeto_f_20110923_207.jpg

Animal burrows on levee slope.
